CHAPTER 12

Mariusz Antolak

THE PRESERVATION AND MODIFICATION OF TREE COMMUNITIES IN THE ACADEMIC CAMPUS KORTOWO IN OLSZTYN

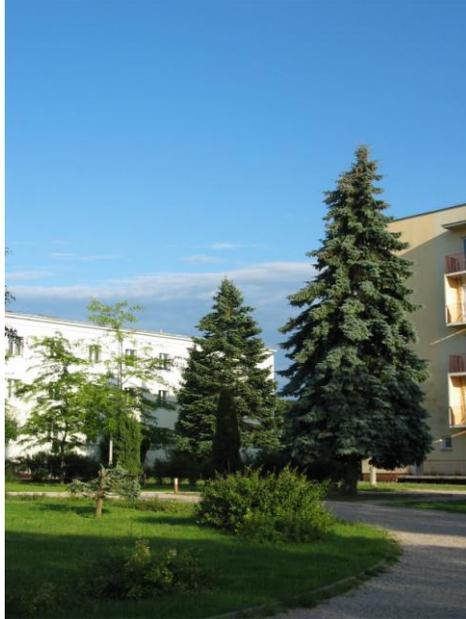
The plants in this sector are in good health (photo 1). The plants in the housing and college areas undergo regular nursing treatments. They are trimmed, formed, rejuvenated and, whenever necessary, cured. The plants introduced along the Kortówka as well as self-sown plants are in a much worse condition. The poorest health state was demonstrated by the trees growing along Warszawska Street, where many specimens are attacked by harmful entomofauna, and many show damaged trunks as well as dry main and side branches. In the sector, 11 dead and 127 diseased or infested trees were found. In addition, 336 trees have visible dry branches in the crown and 90 plants were diagnosed to suffer from gradually progressing decline. 132 trees have visible trunk damage. The asymmetric crown occurs in

Phot.1. Arrangement of the plants near the student residence house number 7. *Source: M. Antolak, July 2008*

272 cases and 317 trees are leaning. The nursing treatments that the trees should undergo are primarily sanitation and rejuvenating trimming, removal of deadwood and pruning of limb stumps. Based on the inventory made, 36 trees were selected to be cut down. They are mainly dead and dying trees or trees severely infested by pests and diseases.

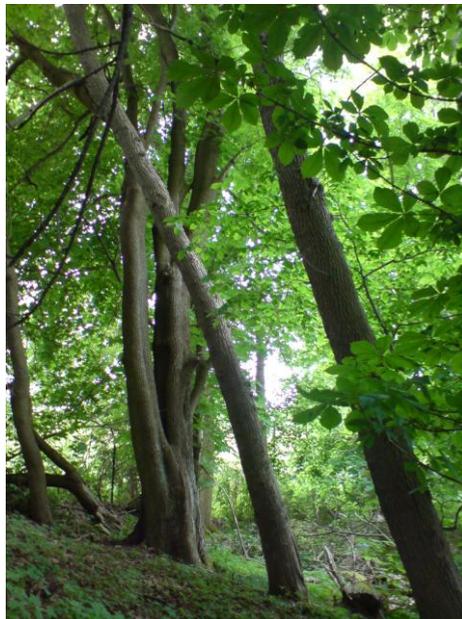
The health condition of the shrubs and trees growing in this sector is not satisfactory. The plants around the marina are in the best condition. The trees and shrubs around the blocks of flats at Heweliusza Street are in a relatively good health state. The main

problem is the incorrect topping and pruning of older trees. However, the health condition of the trees growing along the lake shore is unsatisfactory (photo 2). All specimens of *Aesculus hippocastanum* found in this area are heavily attacked by *Casaria ohridella*. Most of the specimens of *Fraxinus excelsior* are burdened with deadwood. Many of the trees belonging to this species are dying. In the lakeshore belt, many trees have toppled down, breaking other, valuable trees growing nearby. Numerous old specimens of *Alnus glutinosa* and *Alnus incana* in this sector have rotten roots and can be blown over by wind. Likewise, rows of trees and shrubs in the Experimental Garden are not in a good health condition. Here, the main problem is the compactness of the plant communities. Moreover, most of the specimens of *Acer platanoides* and *Acer pseudoplatanus* have been attacked by *Rhytisma acerinum* (an early stage of tar spot of maple tree leaves). Most *Picea abies* are infested by *Ips typographus*. Some trees have been tied to a fence with a wire, which inhibits their further growth. 41 dead and 42 badly diseased or attacked by pests have been identified in the sector. 288 trees have visible dry branches in the crown and 163 have deadwood. 213 trees have visible trunk damage. Asymmetric crowns have been noticed in 160 cases. It was worrying to observe many trees with strongly inclined trunks, which in many cases disturbs the static balance of a tree. In the whole sector, there are 231 leaning plants, including 125 strongly inclined ones. Several nursing treatments should be carried out in the sector, aiming at enhancing the health condition of the tree stands. The main ones are sanitation trimming and removal of foreign bodies from trees (removal of deposited organic matter and water, untying of barbed wire), placing traditional and pheromone insect traps, removal of infested trees, hanging nesting boxes for birds. 166 trees in the whole sector have been chosen to be cut down. They are divided into three groups: to be removed urgently (13 trees), to be removed (116 trees) and to be possibly removed (37 trees). Among the trees which should be urgently cut down are mainly *Picea abies* specimens, which can contribute to a rapid spread of *Ips typographus* over other trees. Other trees indicated to be removed are the fallen ones, which endanger the static balance of other trees. The list also contains dead and dying trees as well as diseased and choked-up plants, which have no chance to develop, as they grow in compact communities and disturb the growth of other, more valuable species. The trees which may be

Phot.2. Poor condition of the trees growing along the bank of the Kortowskie Lake. *Source: M. Antolak, May 2008*
